WATERSHED SURVEY REPORT

Threemile Pond

OCTOBER 2025

THREEMILE POND WATERSHED SURVEY REPORT

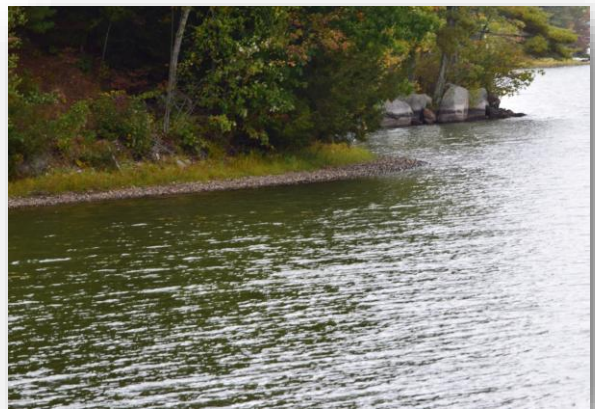
Algae bloom at Threemile Pond, October 2020 (TMPA).

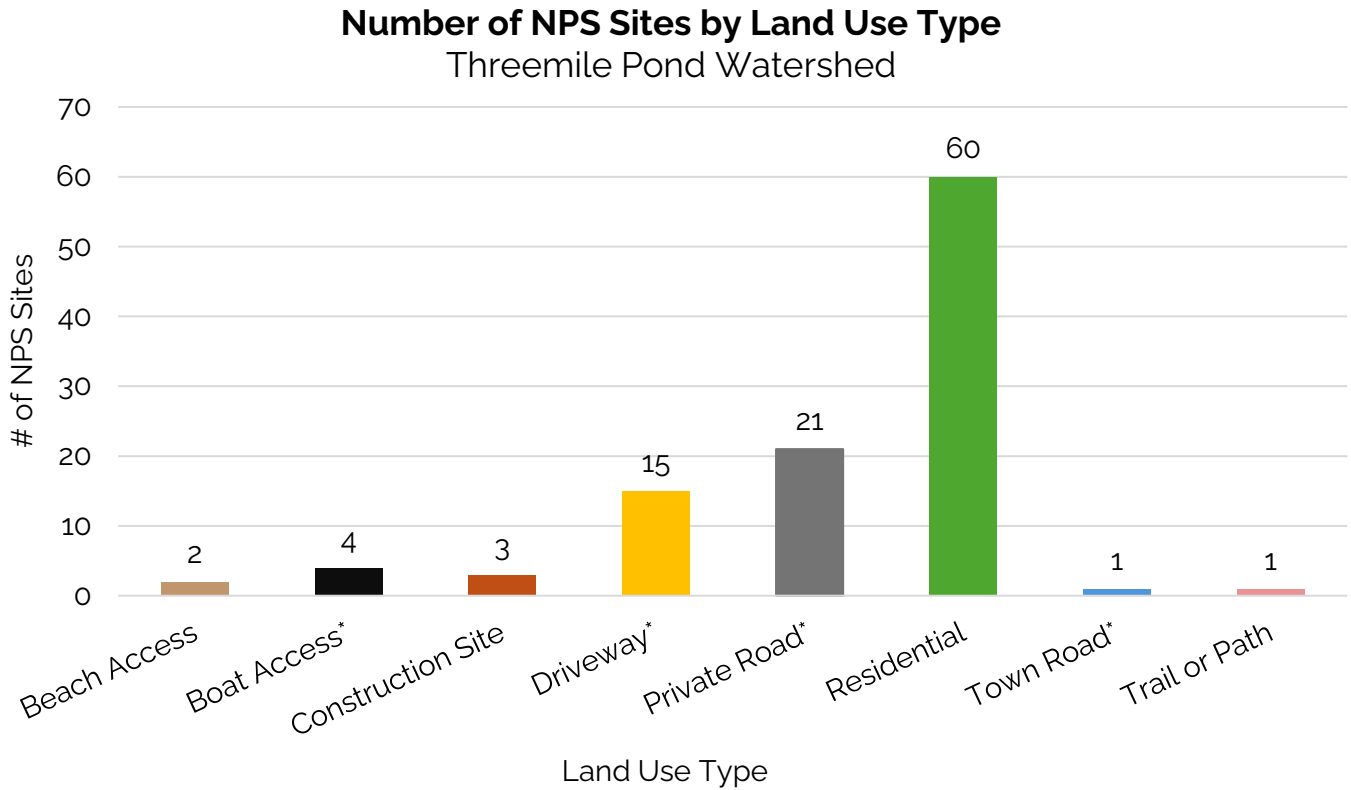
Figure 2. NPS sites in the Threemile Pond watershed by land-use type.

Impact of NPS Sites: The impact that documented NPS sites may have on water quality was determined in the field based on the proximity to a waterbody, and the magnitude of the problem. Factors such as slope, soil type, amount of eroding soil, and buffer size are also considered. A closer look at the estimated impact of these sites shows 7% of sites ranked high impact (7 sites), compared to 53% of sites ranking low impact (57 sites) and 40% of sites ranked medium impact (43 sites) (Table 1, Figures 3 & 4). The seven high impact sites are evenly distributed across driveway, private road, residential, and a construction site (Table 1). Medium impact sites are largely residential (16 sites) and private road sites (15). Of the 57 low impact sites, 74% are located on residential properties (42 sites), followed by private roads (15 sites), boat/beach access (4 sites) with the remaining two sites on a town road and construction site (Table 1).

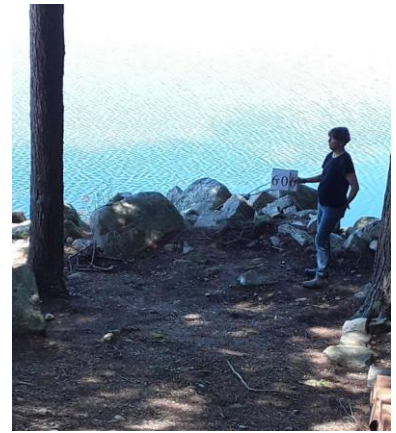
Residential: Residential sites made up 56% (60 sites) of sites identified in the Threemile Pond watershed. Common NPS problems identified on residential sites included bare soil, shoreline erosion and inadequate shoreline buffers. Roof runoff and problems related to unstable shoreline access were also frequently noted. Only two of the 60 residential sites ranked high impact, 16 ranked medium impact, and 42 ranked low impact.

Bare soil on a residential site with an inadequate shoreline buffer

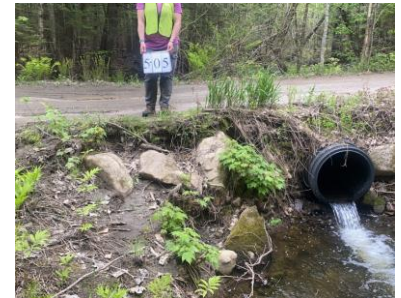
- ▶ Including town roads, private roads and driveways, there are 37 road-based sites (35%).
- ▶ The greatest number of problems were identified on **private roads**, followed by driveways, with only one town road site (Table 1). Many of the problems on private roads are related to poorly functioning culverts and shoulder erosion. Only two of the 21 private road sites ranked high impact. Branstrom Road had the greatest number of sites with three low or medium impact sites.
- ▶ The one **town road** site was on Weeks Mills Road, and is associated with a culvert that is too short for the road which has resulted in erosion along the sides. The site was rated as low impact.
- ▶ The 15 **driveway** sites are associated with unpaved driveways and usually involved different types of surface erosion. Largely they are low or medium impact, with only two driveway sites being ranked high impact.

An unstable inlet/outlet around a culvert on a private gravel road

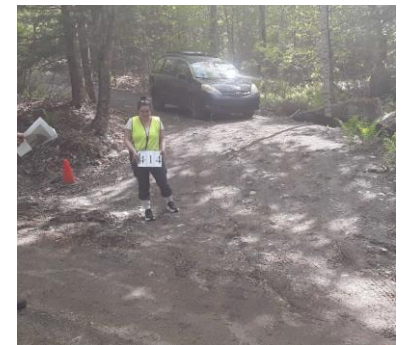
A high impact driveway site that is eroding into a stream to Threemile Pond

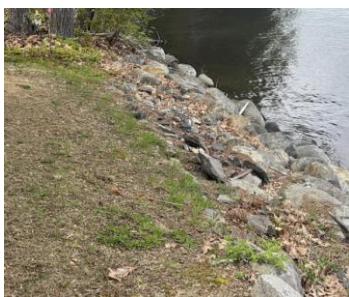
Land Use	Common Issues	Recommendations	Photo
Residential	Surface Erosion	Runoff Diverters, Erosion Control Mulch, Revegetate

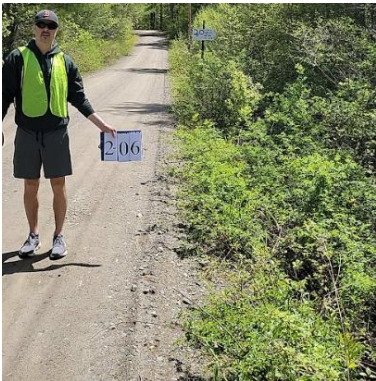
Bare Soil	Limit Raking, Reseed Lawn, Erosion Control Mulch	
	Lack of Vegetation	Plant Buffer or Rain Garden, Live Stakes	
	Roof Runoff Erosion	Infiltration Trench, Drywell at Gutter Downspout	
	Unstable Paths	Infiltration Steps, Crushed Stone, Runoff Diverters, Erosion Control Mulch	
Private Road/Driveway	Surface Erosion	Crown, Add Gravel, Waterbars

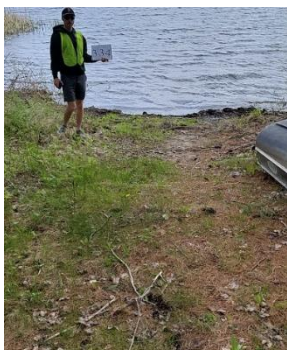
Unstable/Broken Culverts	Install or Replace Culvert, Armor Inlet/Outlet, Remove Clog	
	Road Shoulder Erosion	Vegetate Shoulder, Remove Grader Berms, Install Turnouts, Install Ditches	
	Ditch Erosion	Reshape Ditch, Armor or Vegetate Ditch, Install Turnouts, Check Dams, Sediment Pools	
	Plow/Grader Berm	Remove Berm, Work with Contractor	
Beach & Boat Access	Surface Erosion	Add Crushed Stone, Runoff Diverters

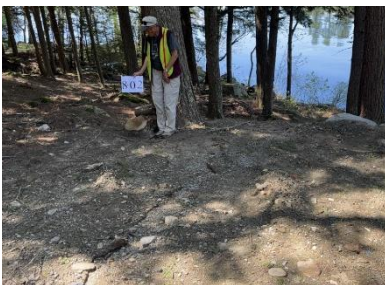
Unstable Shoreline Access	Define Foot Paths, Erosion Control Mulch, Add Vegetation, Infiltration Steps, Waterbars	
	Shoreline Erosion	Toe Slope Protection, Add Vegetation, Establish Buffer	
Construction	Surface Erosion	Silt Fence/Erosion Control Berms, Revegetate

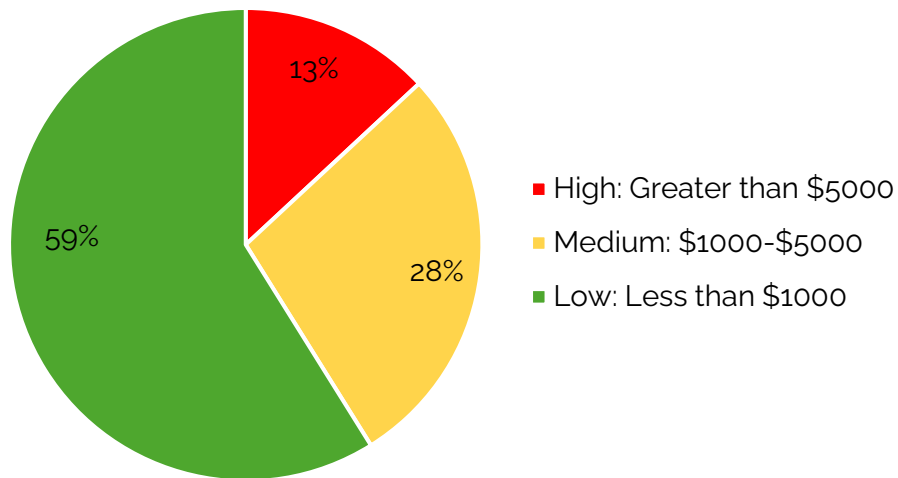
Figure 5. *Estimated cost of NPS sites in the Threemile Pond watershed.*

Cost of NPS Sites: Along with recommendations for addressing erosion at identified NPS sites, surveyors estimated the cost of labor and materials for improving each site. Fourteen of the 107 sites are estimated to incur a high cost (over \$5,000), 30 are estimated to be medium cost (\$1,000-\$5,000), and the remaining 63 of sites have a low estimated cost to fix (under \$1,000). The high cost sites are mostly associated with private roads (8 sites) with a few sites on residential properties, driveways and a construction site. While some roads have road associations to coordinate improvements, not all private roads do. Strong property owner commitment to erosion reduction is needed to reduce runoff that negatively impacts water quality as many of the sites that should be prioritized are privately owned.

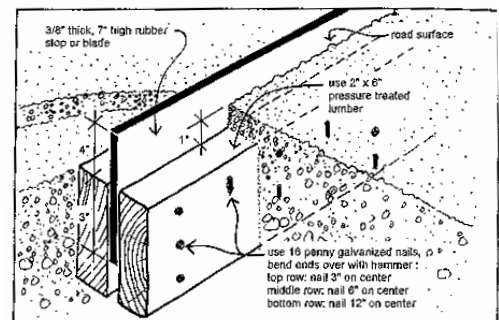
Rubber Razor Blade: Use this structure in a gravel driveway or camp road. It can be plowed over only if the plow operator is aware of its presence and lifts the plow blade slightly. Place it at a 30 degree angle to the road edge and direct the outlet toward a stable vegetated area.

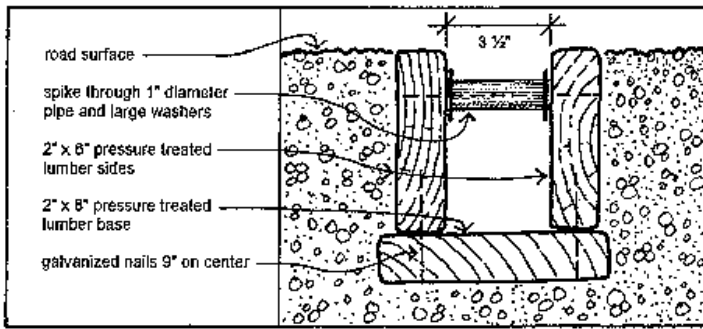
Open Top Culvert: Use this structure in a gravel driveway or camp road that does not get plowed in the winter. Place it at a 30 degree angle to the road edge and point the outlet into stable vegetation. Remove leaves and debris as needed.

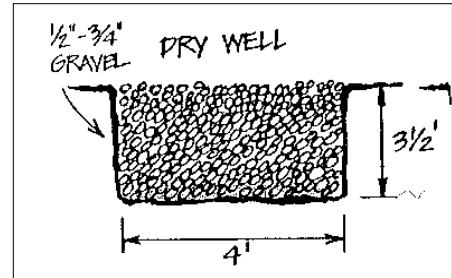
Drywell: Use a drywell to collect runoff from roof gutter downspouts. Drywells can be covered with sod, or left exposed for easy access and cleanout. Drywells and infiltration trenches work best in sandy or gravelly soils.
